HISTORIC PROPERTY INVENTORY FORM

Field Site No. 300 Area Process Ponds OAHF No. _____ Date Recorded 28-Apr-99
Site Name Historic 300 Area Process Ponds
Common _____
Field Recorder Jim Sharpe
Owner's Name U.S. Department of Energy, Richland Operations Office
Address P.O. Box 550
City/State/Zip Code Richland, WA 99352

Address North and South Process Ponds, 300-Area
City/Town/County/Zip Code Richland/Benton County/99352
Twp 10 Range 28E Section 2 W 1/2 1/4 1/4 Sec
Tax No./Parcel No. Acreage
Quadrangle or map name Ric hland, WA. 1992
UTM References Zone 11 Easting 325150 Northing 5138900
Plat/Block/Lot
Supplemental Map(s)

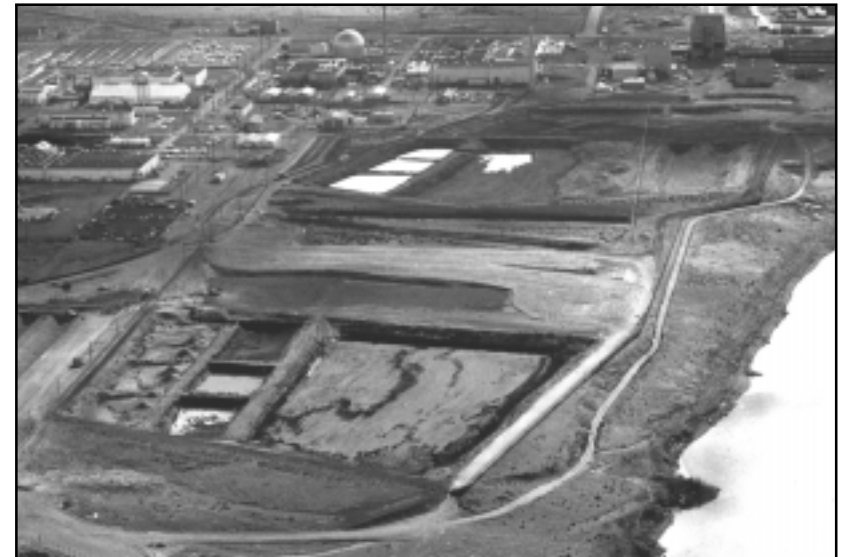
Photography Neg. No. 67334-33
(Roll No. & Frame No.)
View of _____
Date _____

The South Pond (316-1) covered about 8.1 acres and operated from 1943-1975. It contained three small settling basins and two large basins. The pond failed in 1948 resulting in an unplanned release. The pond failure resulted in the creation of the North Process Pond. The inlet to the South Pond was initially located at the southwest corner, but in 1953 the addition of a new process sewer created the need to relocate the inlet to the northwest corner. It received liquid wastes from the 313, 314, 32, and 3706 Buildings, small quantities of organic wastes containing uranium, water from fuel processing floor drains, and aqueous wastes from laboratories.

The North Pond (316-2) The North Pond was constructed as a replacement facility for the South Pond following the failure of the dike near the northeast corner of the South Pond. The failure was later repaired and both ponds were used alternately and simultaneously until 1975. It covered about 10 acres and operated from 1948-1975. The North Pond contained three small settling basins and one large basin. The settling basins were replaced in 1961 or 1962. The original basins were used for sediment disposal. The inlet for the North Pond was in the southwest corner.
